## B&W 801 Series 80

S/N 1251 & 1252 January 1980 → August 2018

## S/N 1251 & 1252

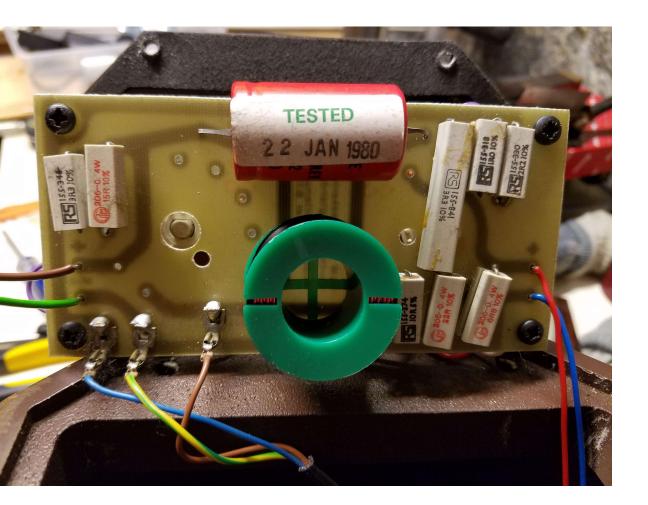
LF enclosures "18 Jan 1980"

EQ board "tested 22 Jan 1980"

XO component date codes 7944, 8001, etc

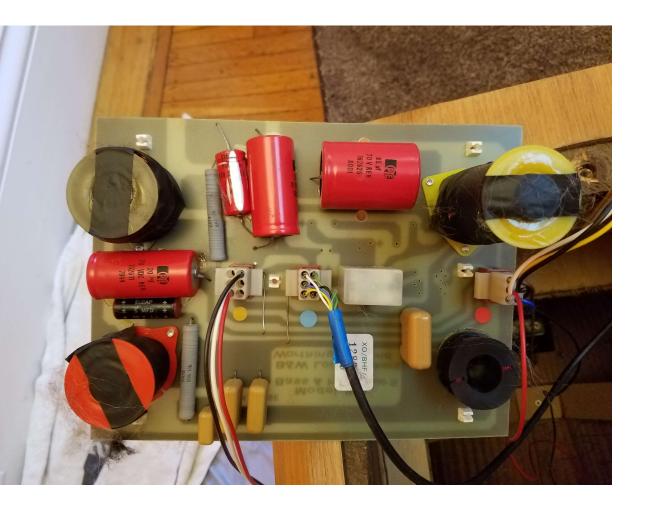
LF & HF crossover board "issue 5"

MF crossover board "issue 3"

Very discolored around power resistors (esp on MF)

- Disconnect the protection circuit and bypass the relay
- Bi-Amp: HF+MF on separate input from LF (including separate ground)
  - New binding posts underneath bass unit
- Replace most crossover components
  - Capacitors Solen PP everywhere, and Mundorf for HF input
  - Resistors Vishay-Mills MRA12 1% (non-inductive 10W)
  - Inductor Solen 2.3mH aircore for MF
- Misc/Cosmetic
  - Scrape & oil bass cabinet (condition was OK, minor dings)
  - Raam deadening mat in MF & LF enclosures
  - Sand & re-paint MF+HF head cabinet
  - New grill cloth from Huntley Audio on ebay
  - Foam OK; remove protection battery & add auralex foam in its place.
